ICE POND DAM  
NH.00145

PHASE I INSPECTION REPORT  
NATIONAL DAM INSPECTION PROGRAM

APRIL, 1979

Identification No: NH00145  
Name of Dam: Ice Pond Dam  
Town: Littleton  
County and State: Grafton County, New Hampshire  
Stream: Alder Brook  
Date of Inspection: November 14, 1978

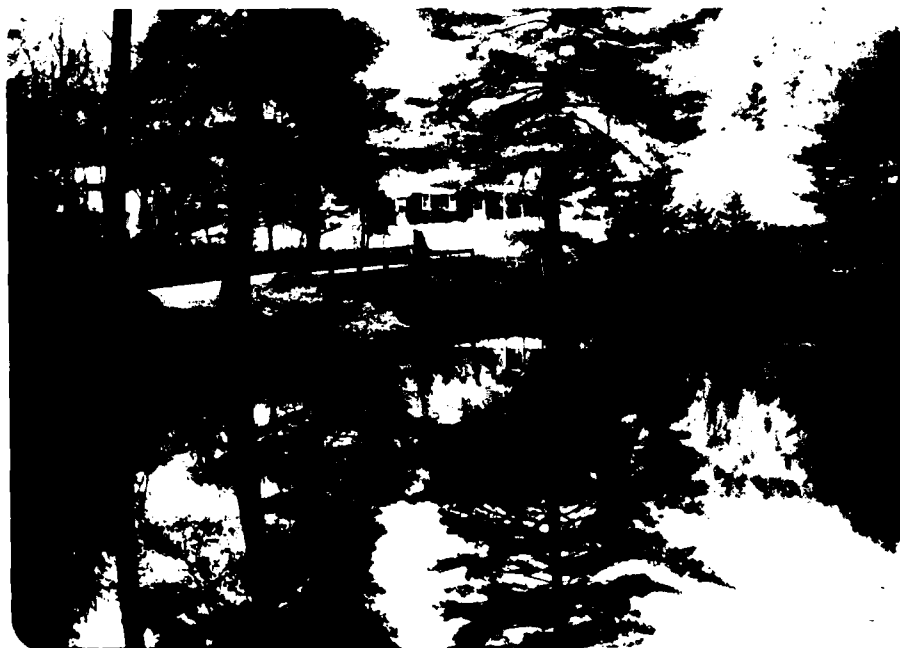
#7. VIEW OF RESERVOIR AREA

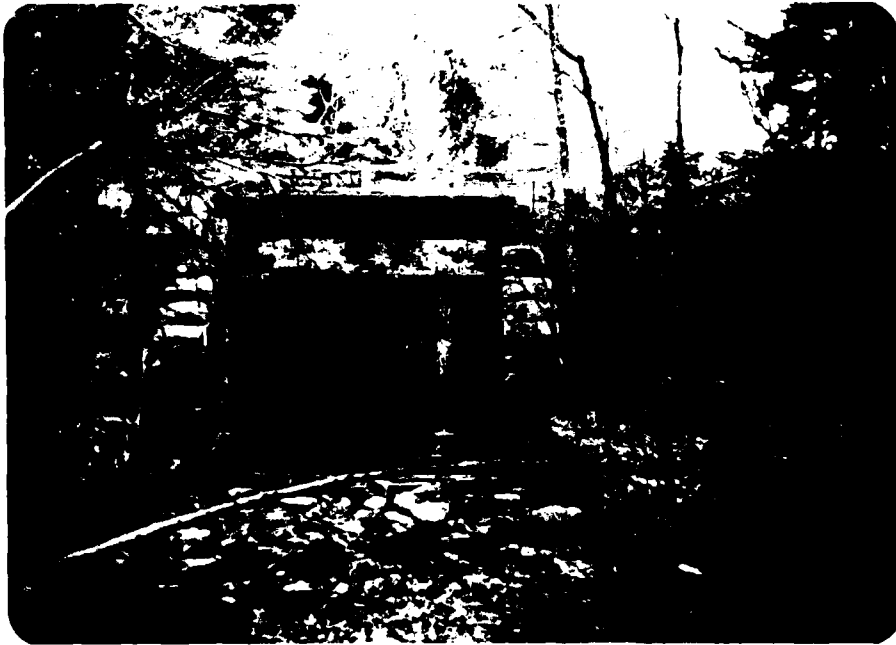
#3. VIEW OF DOWNSTREAM SPILLWAY FACE AND TRAINING WALL

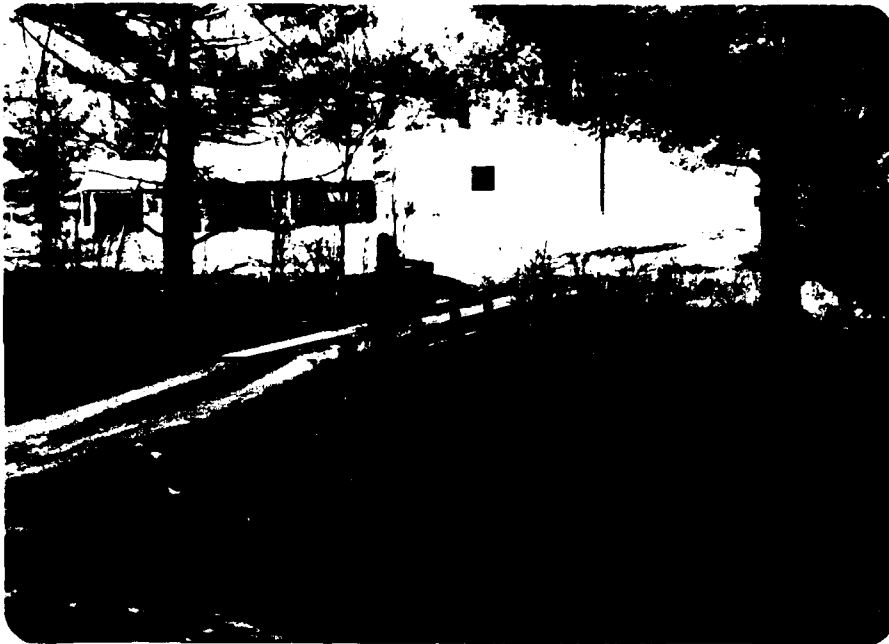
The upstream training walls are stone masonry with several voids and loose stones. Several small trees are growing from the top of the wall (see Photo 1).

#1. VIEW OF TOP OF DAM AND ACCESS BRIDGE  
OVER THE SPILLWAY
